Indented Firewall

by Bob Bidonde

Is there such a thing in Model A Fords? There sure is and it is peculiar to 1931 Model A & AA vehicles. The indented firewall was phased into factory production starting in April 1931 and reached 100% production use in May 1931 according to a factory service bulletin. However, the indented firewall was only one part of a much larger design change that encompassed replacing the gasoline tank in all Model A & AA production. If you have the Ford Service Bulletin for May 1931, page 560, refer to it while you read this article.

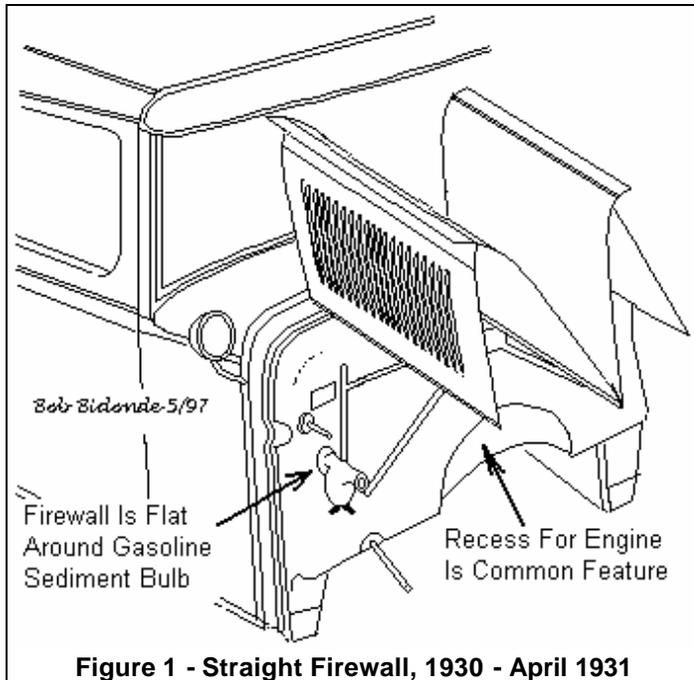
Figure 1 - Straight Firewall, 1930 - April 1931

Figure 1 shows the traditional flat firewall typical of Model A & AA vehicles produced throughout 1930 and until about April 1931. Now compare the flat firewall in Figure 1 to the indented firewall in Figure 2. There are several differences apparent: the indent; the stiffening ribs; the patent data plate location; the new gasoline shutoff valve. This

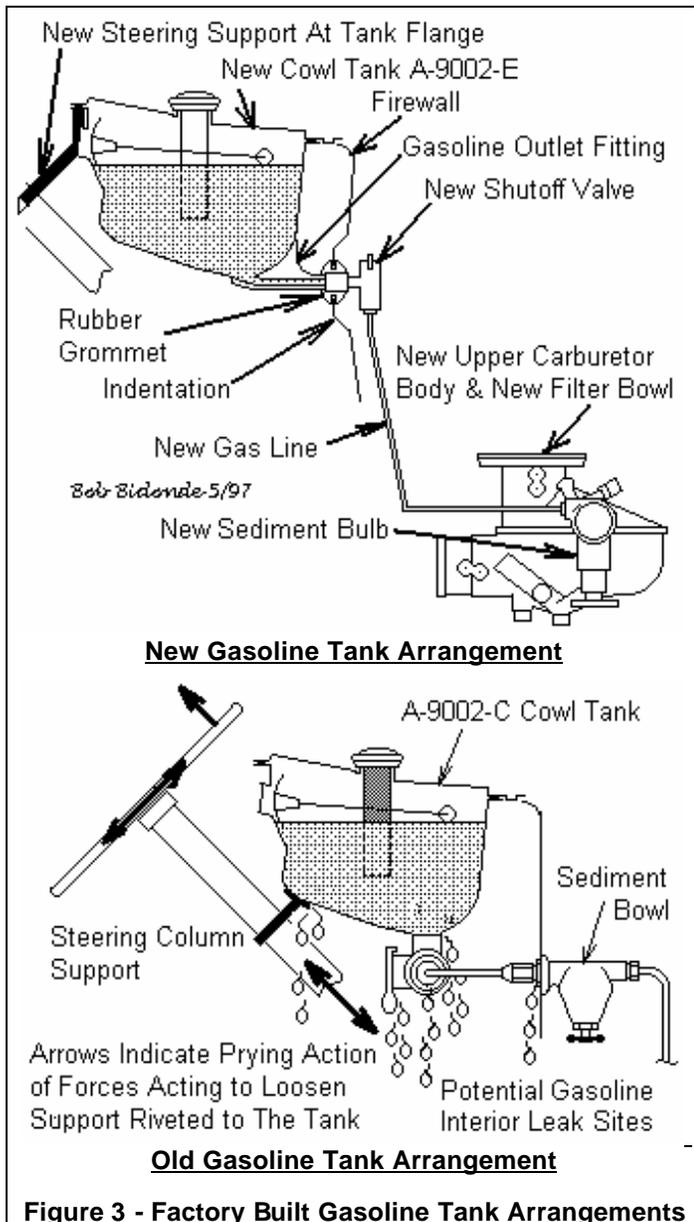
Figure 3 shows the "as built by the factory" arrangements of the old A-9002-C and new A-9002-E cowl tanks. Observe these differences:

- the indent in the firewall connects the new gas shutoff valve directly to the outlet fitting on the tank which eliminates the gas line inside the car;

- there is only one potential leak point inside the vehicle in the new design in contrast to 5 potential leak points in the old design;
- the gasoline shutoff valve, which was originally inside the vehicle and mounted directly to the bottom of the gasoline tank, is now outside on the firewall;

- the new shutoff valve brought about the demise of the cast iron sediment bulb. A new sediment bulb is attached to the side of carburetor and the upper body of the carburetor has the gas inlet port relocated;

- the steering column support was removed from the gasoline tank redesigned to pickup the body at the dash rail just below the windshield opening;
- the indentation in the firewall, in which the new shutoff valve sits, gives rise to the term "indented firewall." Don't confuse this with the centrally located recess behind the engine that is common to all Model A's & AA's.

Some possible business and technical reasons for the new gas tank design and indented firewall can be deduced from Figure 3:

- the steering column support is riveted to the old gasoline tank. Unfortunately, chassis twisting and loading from operating the steering eventually loosen the support attachment causing the tank to leak;
- several cities would not license Model A Taxis because of the potential for gasoline leakage inside the

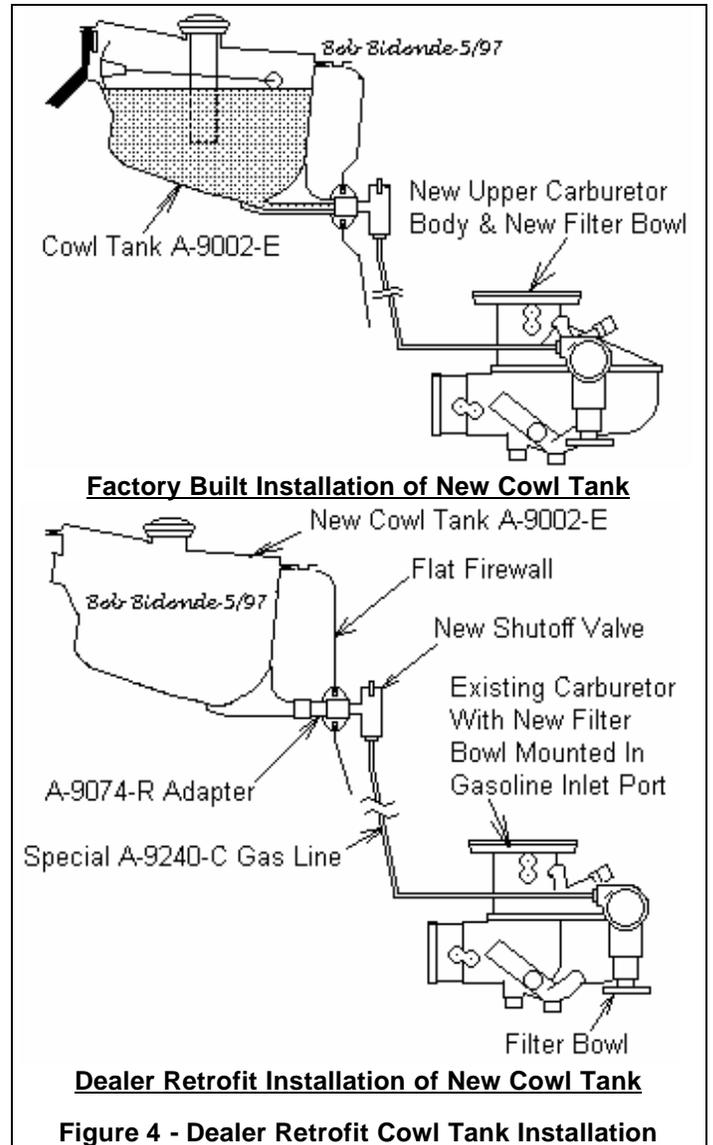
dealer likely would have retrofit the new A-9002-E tank into the damaged Victoria as shown in Figure 4. Figure 4 is like Figure 1162 of the May 1931 Service Bulletin.

The retrofit installation makes use of the old carburetor by mounting the new side filter bowl directly into the gas inlet port. Compare the carburetors in Figure 4 and note the difference in filter bowl locations. Although mounting the new filter bowl in the inlet port of the existing carburetor dictated the special retrofit gas line A-9240-C, the special line saved the customer the cost of replacing the more expensive carburetor.

Also note the special retrofit A-9074-R adapter. As far as potential gasoline leakage is concerned, the adapter was a step backward, but it too reduced the customers cost. The alternatives Ford avoided would have been considerably more expensive to the customer, (a) producing a cowl tank with a special fitting to reach the straight firewall or (b), retrofitting the indented firewall.

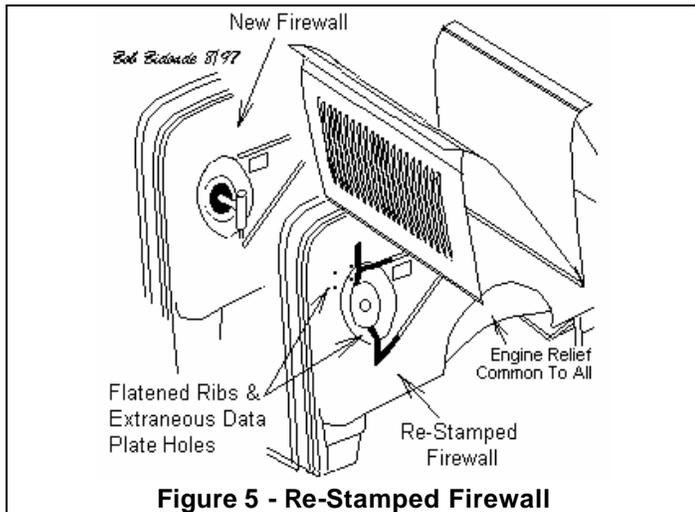
There are 2 different styles of indented firewall. At the time the new cowl tank installation started going into production, Ford had a stockpile of straight firewalls. These

were re-stamped to add the indentation. As a result, some of the stiffening ribs, shown dark in Figure 5, were flattened. The patent data plate was relocated, but the 4 patent plate attachment holes in the old location were left open.
